HomePro Home Inspections llc

Client: HomePro Sample

Subject Property:

123 Anywhere Ave  
Some Town, MN. 55991

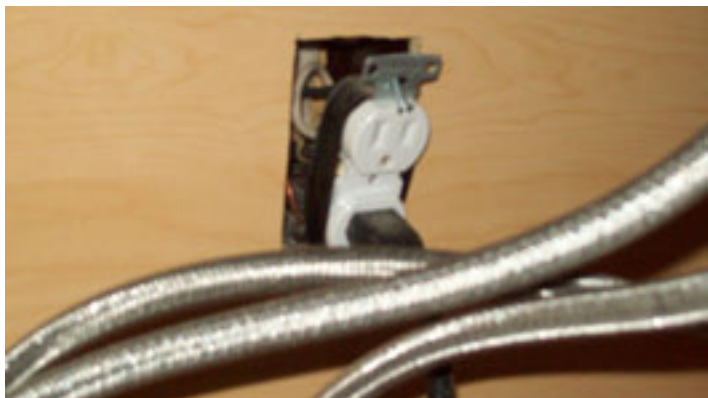
Duplex below kitchen sink, (disposal)

Duplex loose/cover plate missing at kitchen disposal, basement bedroom. Recommend GFCI on all kitchen counter outlets (2)(4).

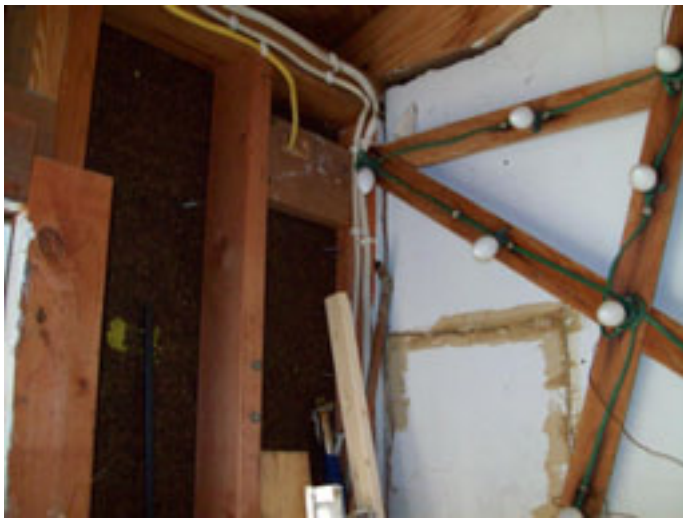
Exposed wiring subject to damage \* (4)

electrical wires subject to damage, (garage)

Comments: GFCI's recommended. Exposed wiring subject to damage(2)(4)

GFCI's recommended. Exposed wiring subject to damage(2)(4)

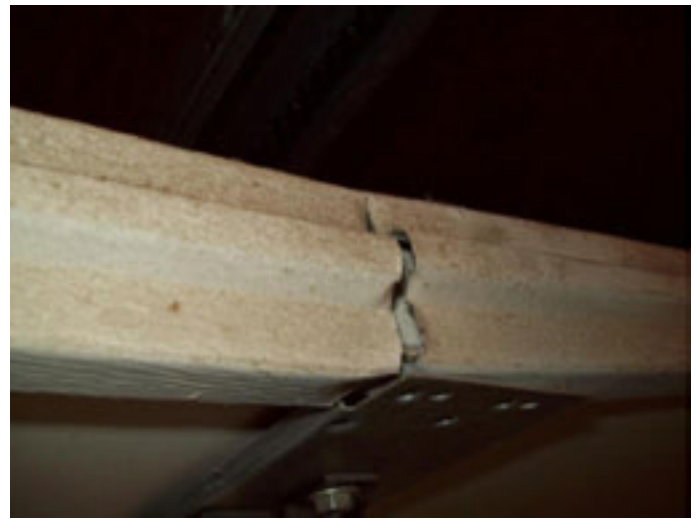
Comments: Top panel cracked at middle(2)

Top garage door panel cracked

Top panel cracked at middle(2)

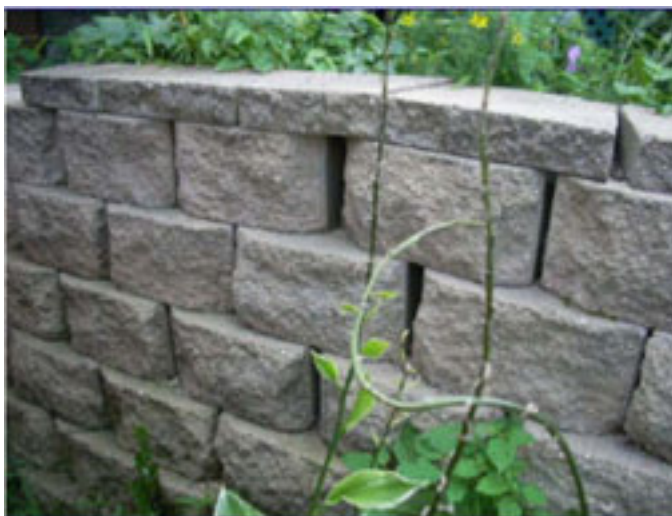
<b>03. Retaining Walls</b>	Repairs Recommended	[X] Deterioration / damage [X] Common cracks *
----------------------------	---------------------	--

Shifting in rear retaining wall

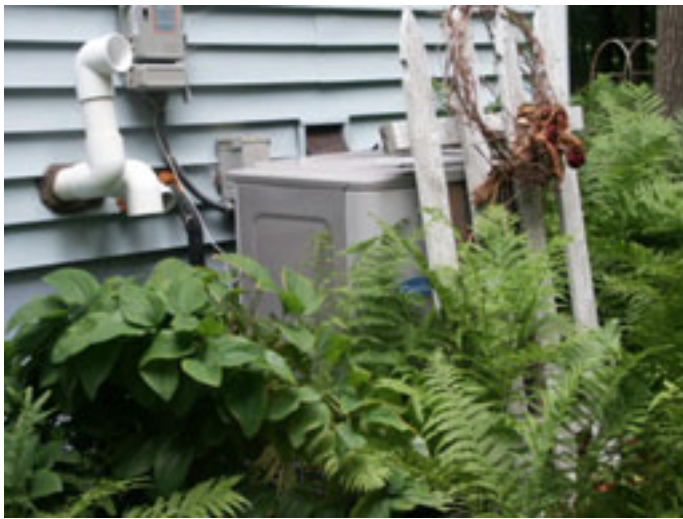
Improper clearance around A/C unit

Location: Left side Type: Central Air ConditioningComments: Recommend cutting back vegetation around A/C to provide adequate air flow \**Notice: The inspector does not perform pressure tests on coolant systems, therefore no representation is made regarding coolant charge or line integrity. Subjective judgment of system capacity is not part of the inspection.***38a. Power**

Recommend cutting back vegetation around A/C to provide adequate air flow \*

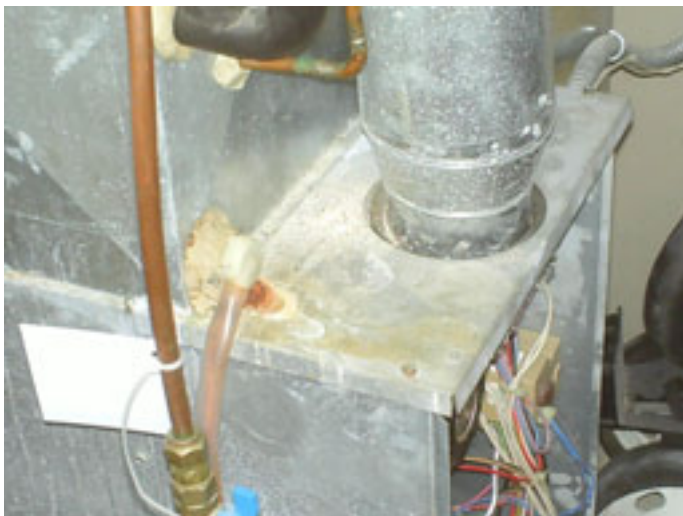
Comments: Rust and debris on interior/exterior due to leak(2)

Rust / debris from vent pipe

Rust and debris on interior/exterior due to leak(2)

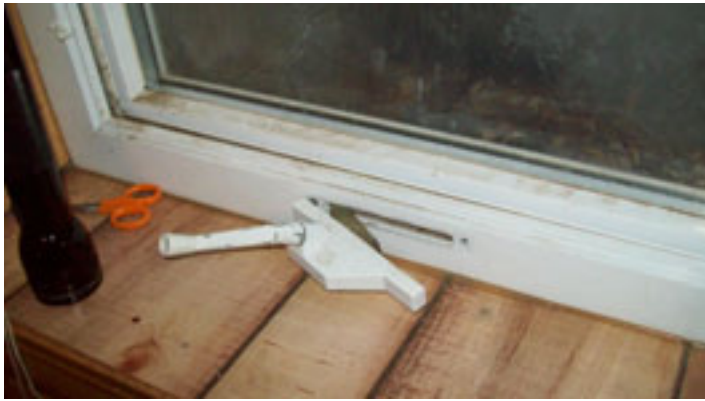
Screens are: appears serviceable Window broken at: Basement Egress (2) (4)  Material: Wood, Vinyl  Type: Double Hung, Crank OutComments: Basement Egress window crank damaged(2)(4). Moisture between panes on family room window \*(2)*Notice: Determining condition of all insulated windows is not possible due to temperature, weather and lighting variations. Check with owner for further information.***49. Interior Walls**

Egress window crank damaged

Basement Egress window crank damaged(2)(4). Moisture between panes on family room window \*(2)

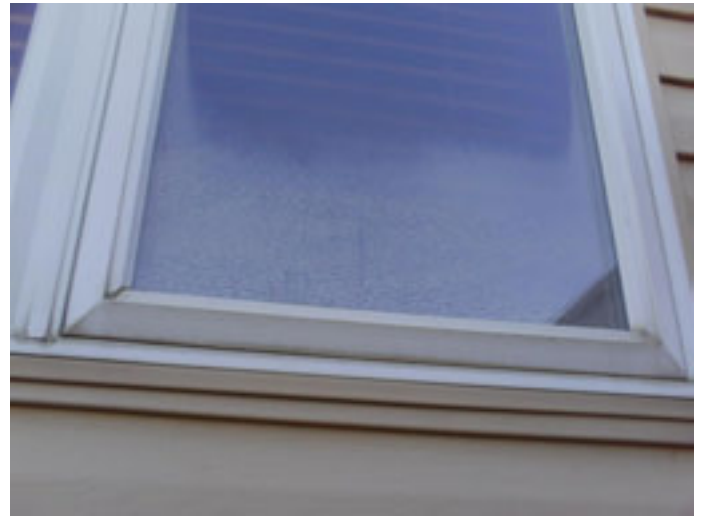
Moisture between window panes

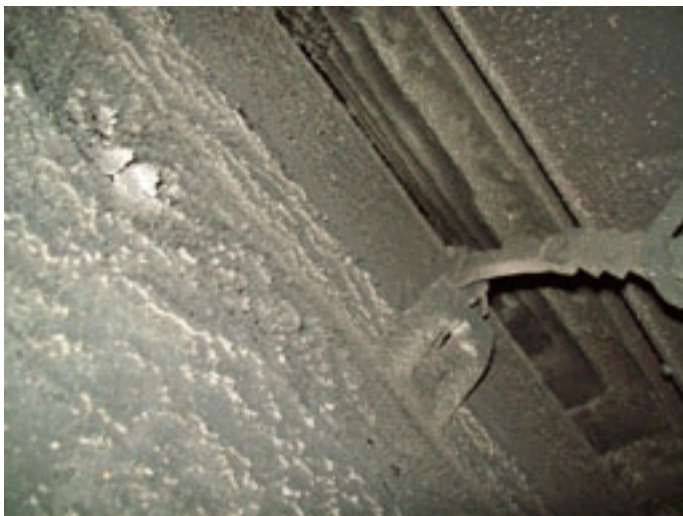
Comments: Creosote build up. recommend evaluation by licensed contractor prior to use (2)(4).

Creosote build up, main fireplace

Creosote build up. recommend evaluation by licensed contractor prior to use (2)(4).

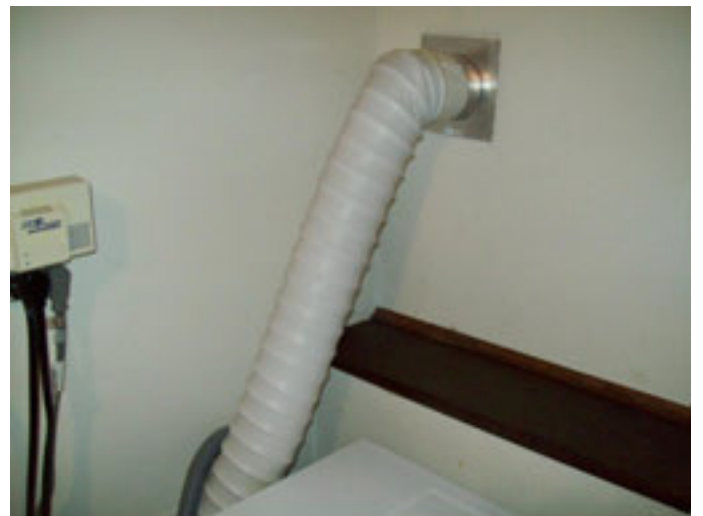
Comments: Dryer vents through improper materials. Recommend smooth bore metal dryer vent to help prevent fire hazard(2)(4)

Dryer vents through improper material

Dryer vents through improper materials. Recommend smooth bore metal dryer vent to help prevent fire hazard(2)(4)

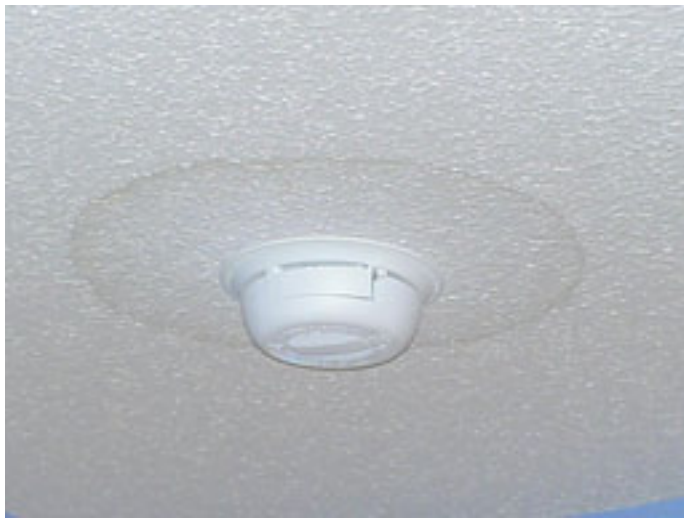
Stains appear to be: Dry\* Stains at: upstairs hallway at smoke detector (2) (3)  Common cracks \*  Acoustic Spray  DrywallComments: No additional comments.*Notice: Determining whether acoustic sprayed ceilings contain asbestos is beyond the scope of this inspection. For more information please contact the American Lung Association or an asbestos specialist.***51. Floors**

Ceiling stain, upper hallway - dry

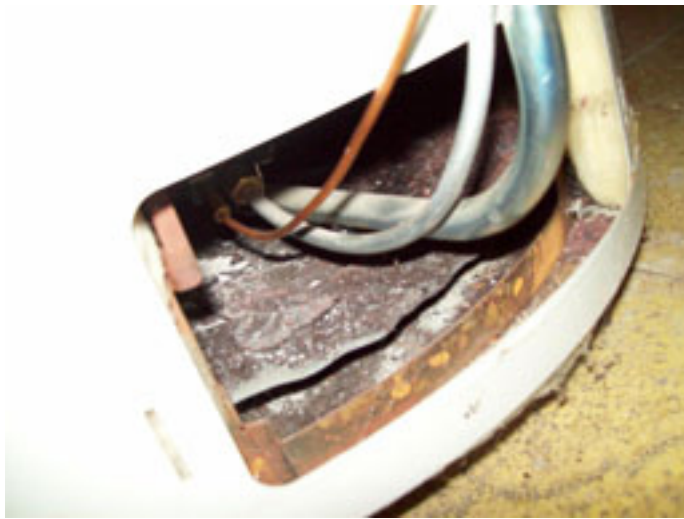
[X] Rust flakes (2) (4) [X] Unusual flame pattern (2)

Rust flakes in chamber

Comments: Recommend evaluation by licensed contractor(2)

Recommend evaluation by licensed contractor(2)

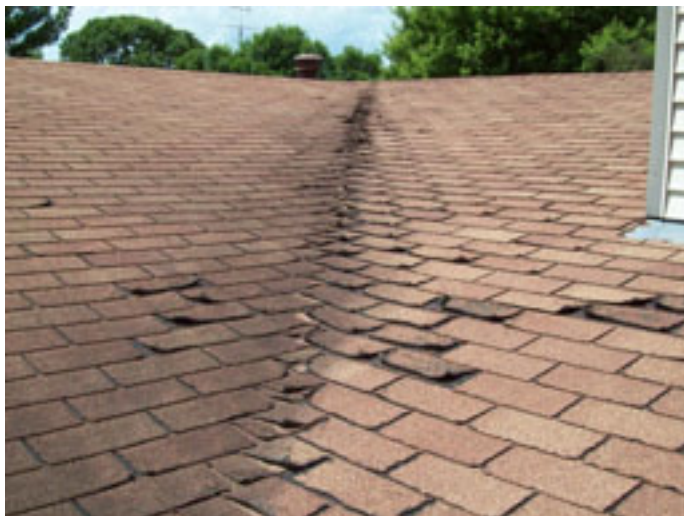
<b>19. Shingle / Shake</b>	<b>Repairs Recommended</b>	[X] Roof inspected by: walking roof
[X] Roof covering is: composition shingles [X] Location: Main, Garage [X] Weathering / aging * [X] Typical maintenance recommended (2) [X] Roof style: Gable [X] Number of layers: 1 <u>Comments:</u> Weathering/aging south and west exposures* (2)

Valley, south west side
